**123 GROVE PARK, SOUTHWARK
BAT ACTIVITY SURVEY**

Title: 123 Grove Park, Southwark
Bat Activity Survey

Project No: AEL 408

Date of Issue: 12 May 2011

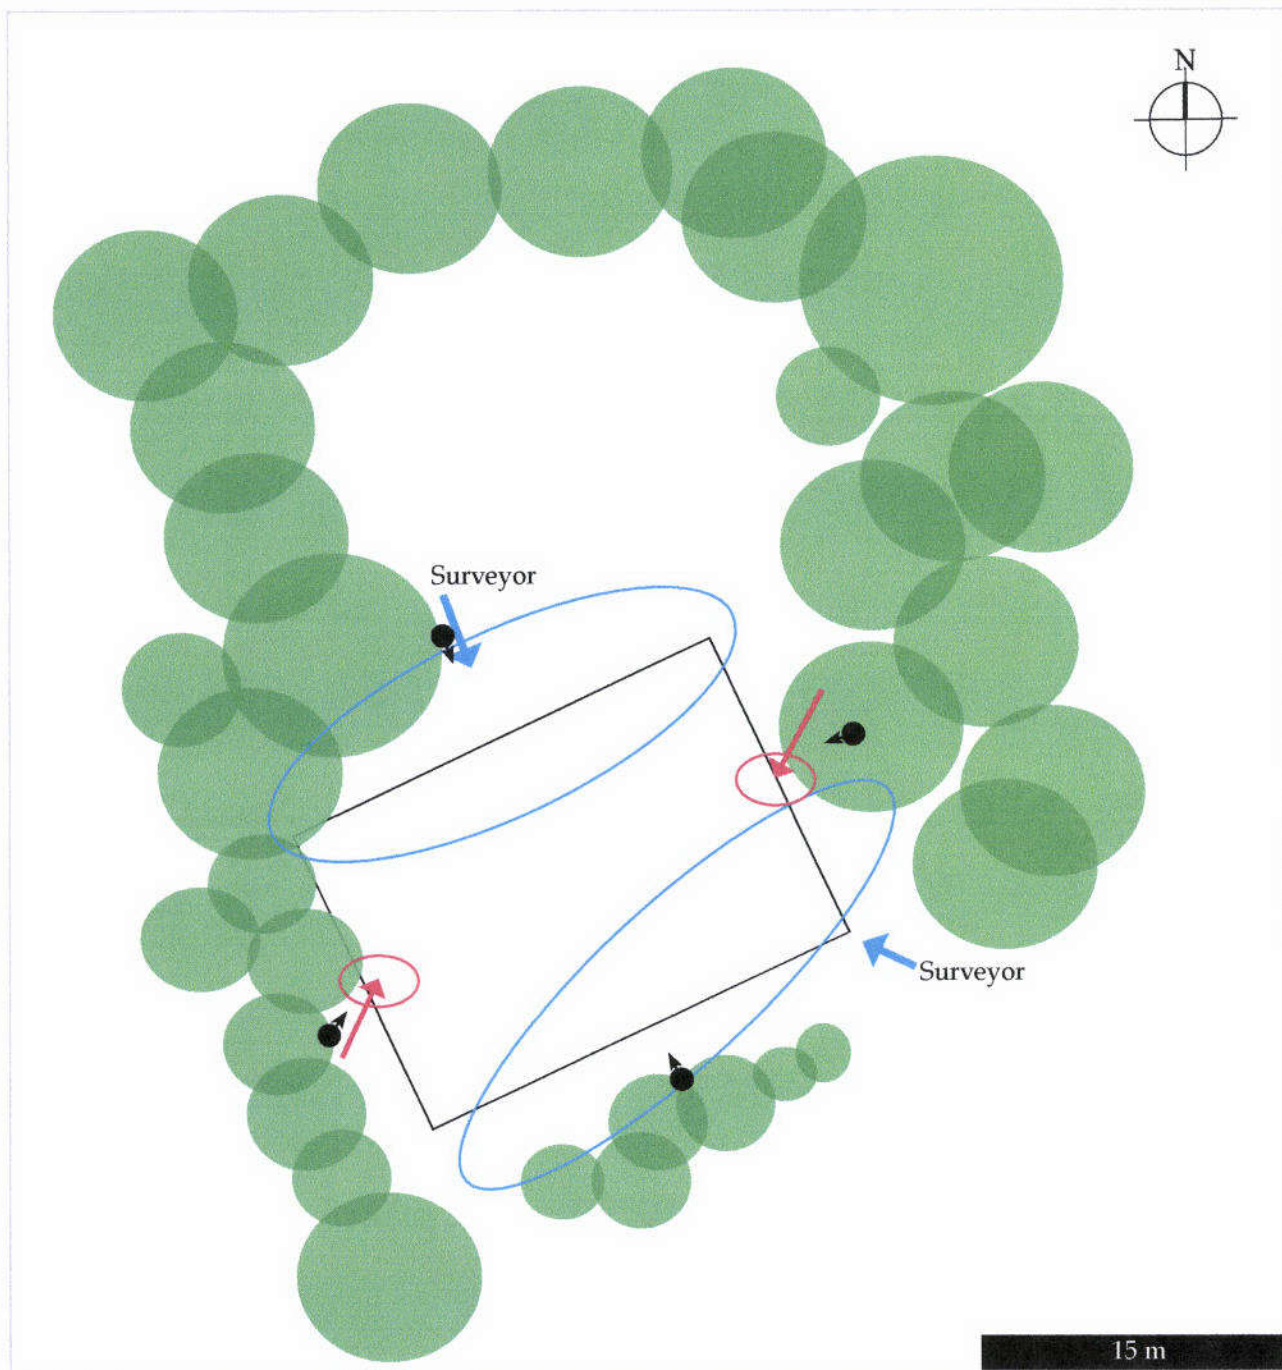
Figure 1: Bat activity survey locations 4-5th May 2011

- 2.2.4 Both surveyors returned to site in darkness the following morning and repositioned the survey equipment in the locations shown by **Figure 1**. The return to roost survey was completed from 04.00 until 05.30 - sun rise was at 05.25. During this time, both surveyors slowly patrolled their respective halves of the building to look for bats returning to roost in the building.

- 2.2.5 Four time-synchronised automated Anabat electronic bat detectors (SD2 models) were employed during the dusk and dawn survey. Each was raised 1.5m from the ground on a tripod with their microphones pointing skyward in the positions shown by **Figure 1**. Both surveyors were equipped with a Pettersson 230 bat detector.

- 2.2.6 Two tripod mounted digital video cameras with infra-red night shoot facility were also used during the survey (dusk and dawn) to film bats emerging from two potential bat access/egress points the western and eastern end of the building missing hanging and roof tiles respectively (see **Figure 1**). An infra-red lamp was used to illuminate both areas being filmed. The video recorders were set to run at five minutes before the start of each survey and were left to record for 84 minutes (the length of the tape) on each occasion

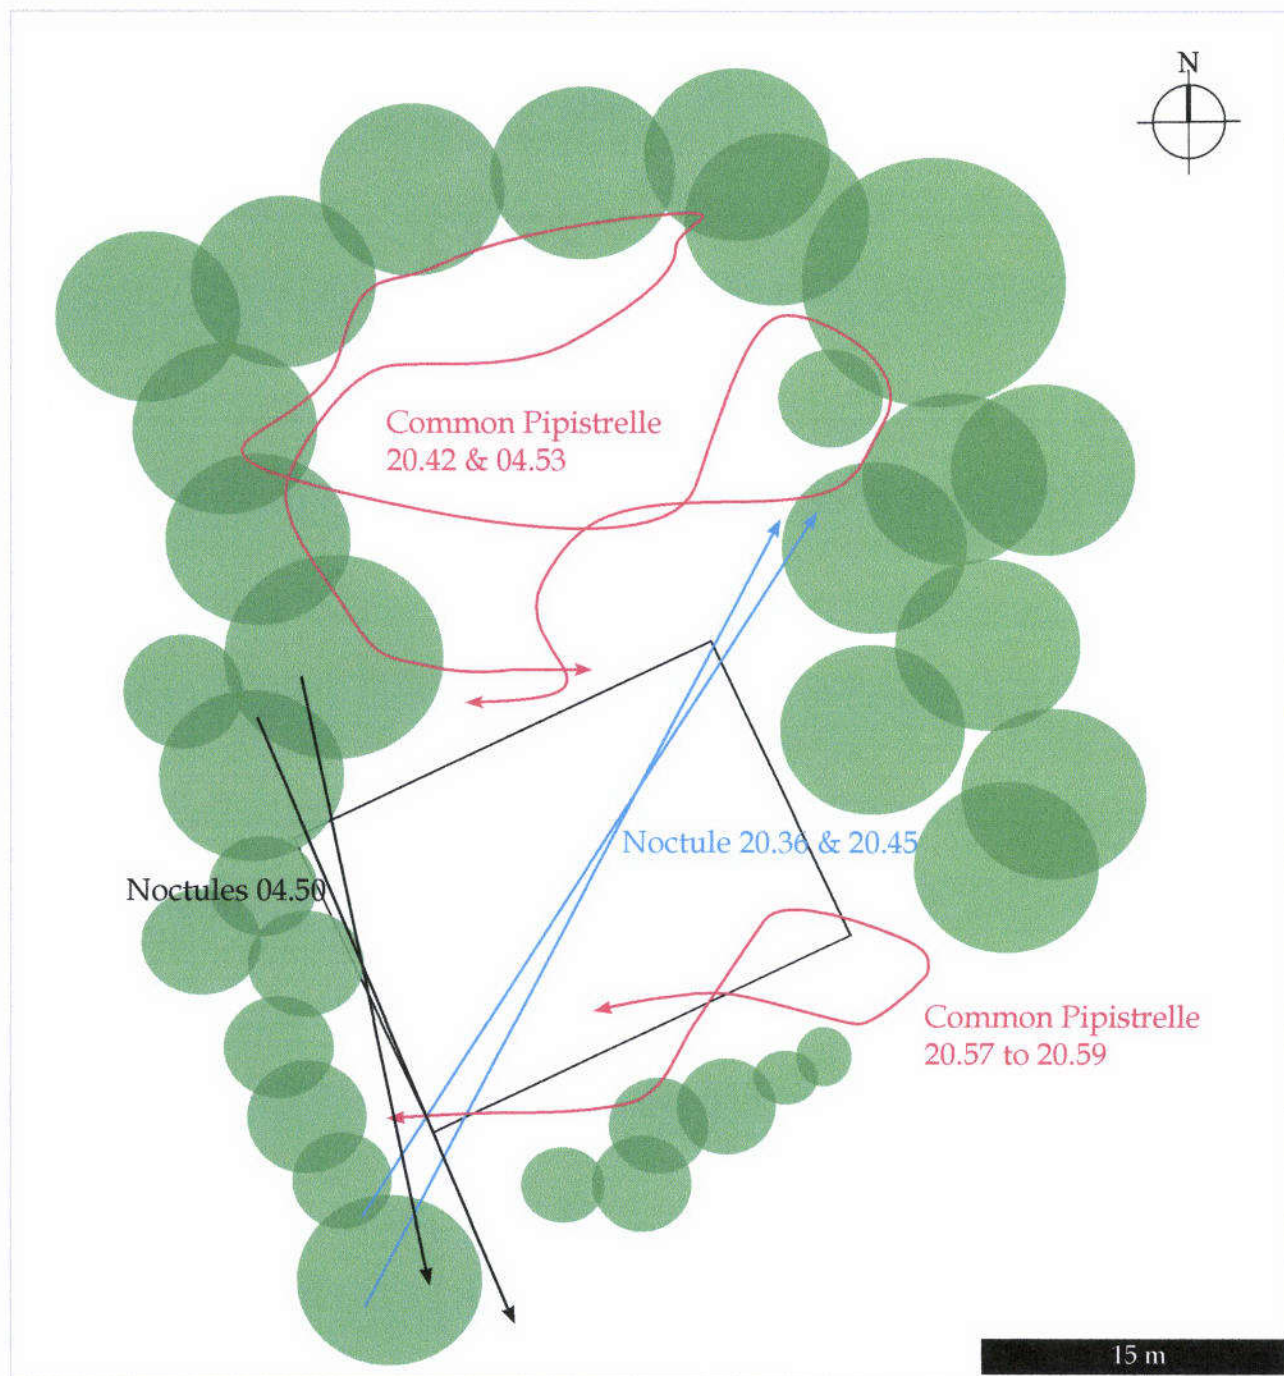
Figure 2: Bat activity survey results 4-5th May 2011

- 3.1.2 The results of the bat activity survey are summarised on **Figure 2**. The first bat calls detected during were those of a commuting *Nyctalus* bat (probably a noctule) that flew high across the site in a north easterly direction from the south west at 20.36 (eight minutes after sun set). A second *Nyctalus* bat commuted across the site in the same direction at 20.45.

- 3.1.3 The next bat seen and recorded was a common pipistrelle *Pipistrellus pipistrellus* from 20.42 until 20.59 which was foraging around both sides of the property. The bat was first seen and recorded at 14 minutes after sun set, and had therefore been roosting relatively close by. Thereafter a single foraging soprano pipistrelle *Pipistrellus pygmaeus* was recorded at 21.13 until 21.19 but the bat was not seen.

- 3.1.4 During the return to roost survey the next morning, a single common pipistrelle was recorded foraging around the back garden area at various times from 04.07 until the last sighting at 04.53 when it flew off site in a northerly direction. Two *Nyctalus* bats were also observed commuting high above the site at 04.50 in a southerly direction.

4.1.1 The results of the survey work completed from March to May 2011 suggests strongly that 123 Grove Park does not support a bat roost, and that the two bat droppings recorded in the roof space were probably the result of a single pipistrelle bat that had flown into the building and investigated the interior of the loft space - probably via a missing window pane in this location.

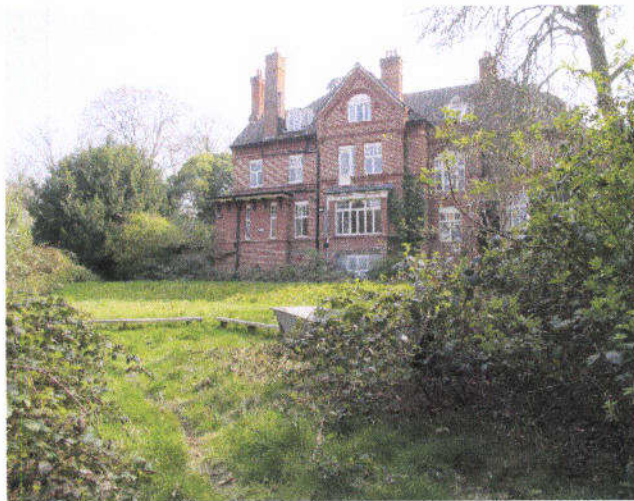
Photo 1

In general the site was in a very similar condition to that reported previously, with the house (see **Photos 1-2**) possessing a number of built features about its exterior that could support crevice roosting bat species including gaps behind soffits (**Photo 3**) and lifting roof tiles (**Photo 4**). No physical evidence of bats was seen on any external surface, and the presence of bats using these features remains, as reported previously, a theoretical possibility only. It is of note that the current survey was completed outside the start of the main bat active season, and therefore evidence of bats (e.g. their droppings) would not necessarily be expected to be visible on exposed areas about the buildings exterior.

A bat activity survey in line with current best practice survey guidance should be completed to verify the presence/absence of roosting bats within the house prior to its demolition. If bats are found to be present, it is likely they will be crevice roosting species (almost certainly *Pipistrelle* bats) roosting in external crevice features. It is of note that such features could be easily replicated in any new building, and it is recommended that bat roost features are incorporated into the exterior of the new building as compensation for the loss of crevice roosting opportunity.

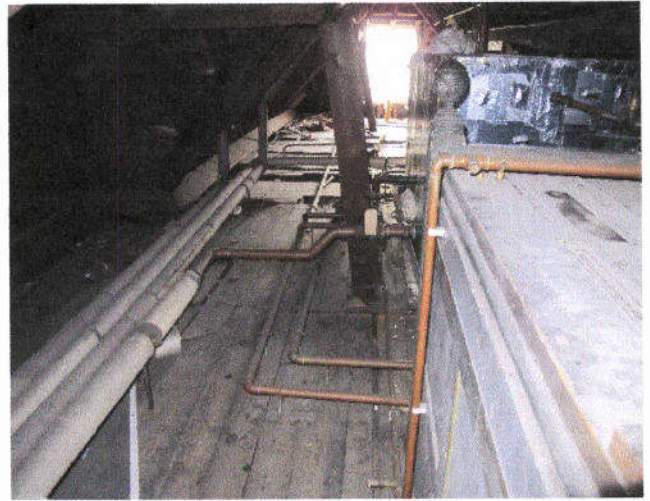
Photo 2

Two old bat droppings of a size and shape consistent with those produced by a *Pipistrelle* bat were present on the lid of a water tank in the loft (see **Photo 2**), but no other evidence of bats was present. This along with the very light conditions within the roof space as a result of gable end windows (some with missing panes of glass), indicates that a large or important bat roost of species that require large roof voids to fly within (e.g. Brown Long-eared bat) is not present, and that any roosting activity is likely to be confined only to the use of crevice type features by *Pipistrelle* bats about the exterior of the property. The two droppings within the loft are considered most likely to have been produced by a single bat making a one off exploratory visit of roof space entering via the window frame with the missing window pane.

1. Ten enclosed bat bricks (Ibstock Type B or similar) to be incorporated in suitable locations within the exterior of the new building (locations to be agreed by a suitably experienced bat worker).

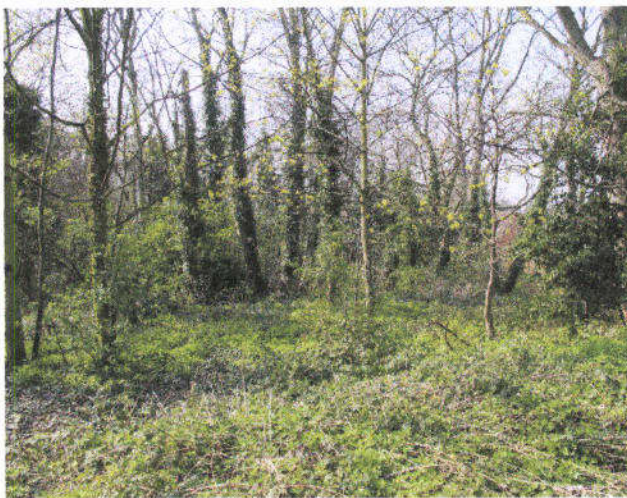
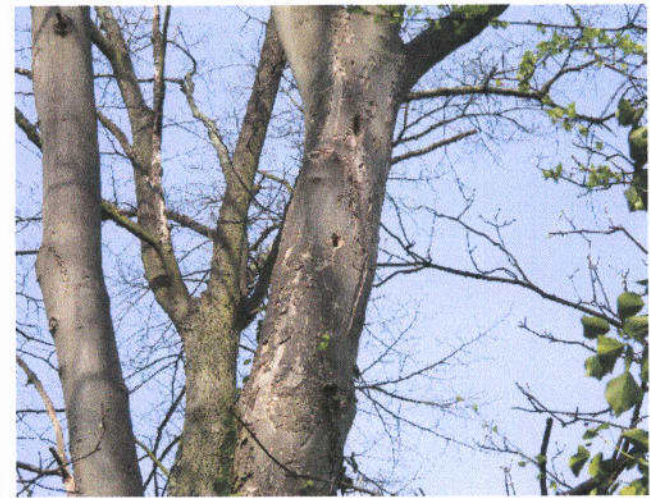
The two sycamore trees in the wooded area of the garden (**Photos 5-6**), reported previously to possess woodpecker holes that could be used by tree roosting bats, were still standing, and it appeared likely that one or both were in use by greater spotted woodpecker at the time of the survey. No obvious evidence of roosting bats was seen in association with either tree.

3. Standing dead trees with bat roost features to be felled at a time when they are least likely to be in use by nesting birds and breeding tree roosting bats in the autumn months (September to early November) immediately after a detailed check has been carried out that birds and bats are absent from them. Trees to be soft-felled if bat absence cannot be verified e.g. if trees prove unsafe to climb. Trees to be felled under the auspices of an EPS licence, as necessary, if the presence of tree roosting bats is confirmed.

4. As compensation for the loss of bat roost potential trees, six woodcrete bat boxes to be mounted in suitable locations on retained trees or other suitable structures within the grounds of the site in locations to be agreed by a suitably experienced bat worker.
