#### ECOLOGY SURVEY REPORT - 123 GROVE PARK, SOUTHWARK

123 Grove Park, Southwark  
Photo-sheet 1 of 1

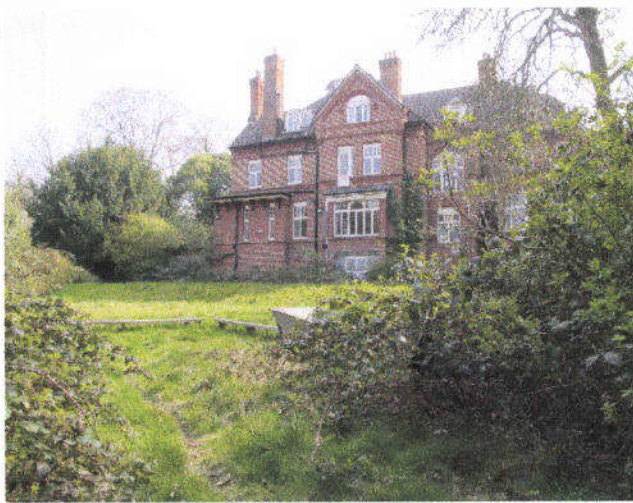
Photo 1

In general the site was in a very similar condition to that reported previously, with the house (see **Photos 1-2**) possessing a number of built features about its exterior that could support crevice roosting bat species including gaps behind soffits (**Photo 3**) and lifting roof tiles (**Photo 4**). No physical evidence of bats was seen on any external surface, and the presence of bats using these features remains, as reported previously, a theoretical possibility only. It is of note that the current survey was completed outside the start of the main bat active season, and therefore evidence of bats (e.g. their droppings) would not necessarily be expected to be visible on exposed areas about the buildings exterior.

A bat activity survey in line with current best practice survey guidance should be completed to verify the presence/absence of roosting bats within the house prior to its demolition. If bats are found to be present, it is likely they will be crevice roosting species (almost certainly Pipistrelle bats) roosting in external crevice features. It is of note that such features could be easily replicated in any new building, and it is recommended that bat roost features are incorporated into the exterior of the new building as compensation for the loss of crevice roosting opportunity.

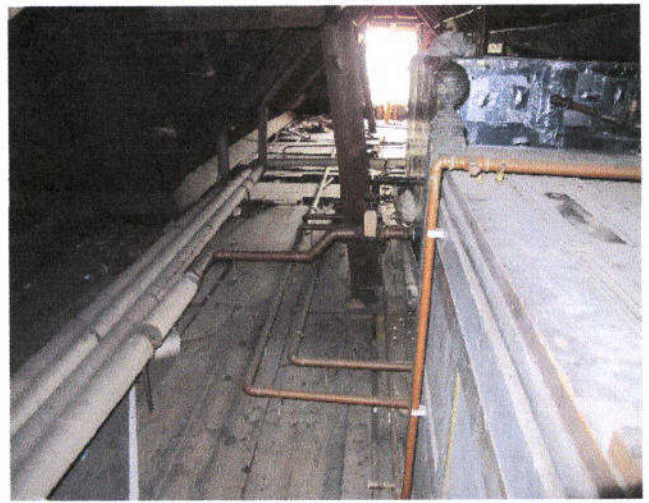
Photo 2

Two old bat droppings of a size and shape consistent with those produced by a Pipistrelle bat were present on the lid of a water tank in the loft (see **Photo 2**), but no other evidence of bats was present. This along with the very light conditions within the roof space as a result of gable end windows (some with missing panes of glass), indicates that a large or important bat roost of species that require large roof voids to fly within (e.g. Brown Long-eared bat) is not present, and that any roosting activity is likely to be confined only to the use of crevice type features by Pipistrelle bats about the exterior of the property. The two droppings within the loft are considered most likely to have been produced by a single bat making a one off exploratory visit of roof space entering via the window frame with the missing window pane.

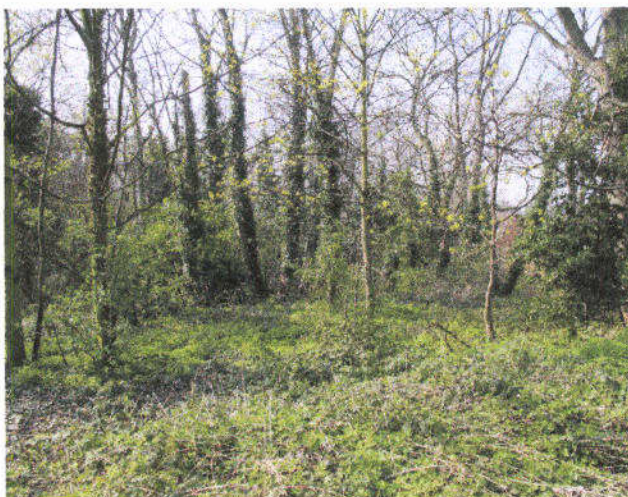
Photo 5

The two sycamore trees in the wooded area of the garden (**Photos 5-6**), reported previously to possess woodpecker holes that could be used by tree roosting bats, were still standing, and it appeared likely that one or both were in use by greater spotted woodpecker at the time of the survey. No obvious evidence of roosting bats was seen in association with either tree.

3. Standing dead trees with bat roost features to be felled at a time when they are least likely to be in use by nesting birds and breeding tree roosting bats in the autumn months (September to early November) immediately after a detailed check has been carried out that birds and bats are absent from them. Trees to be soft-felled if bat absence cannot be verified e.g. if trees prove unsafe to climb. Trees to be felled under the auspices of an EPS licence, as necessary, if the presence of tree roosting bats is confirmed.

4. As compensation for the loss of bat roost potential trees, six woodcrete bat boxes to be mounted in suitable locations on retained trees or other suitable structures within the grounds of the site in locations to be agreed by a suitably experienced bat worker.
